GO Number	S/A Number	Page 1 of	Total Pages	Rev. Ltr/Chg. No. See Summary of Chg.	Number
97055	61000	150	151	A	EID-04628
Program Title CLOSURE OF ETEC (R21-RF)					
Document Title FINAL REPORT FOR DECONTAMINATION & DECOMMISSIONING OF FORMER SODIUM DISPOSAL FACILITY (FSDF) - B/4886					
Document Type OPERATIONS (D&D) REPORT			Related Documents		
Original Issue Date 10-5-99		Release Date 11-17-99 <b>RELEASE</b>		Approvals R. D. Meyer	
Prepared By/Date Alex Klein 9/29/99		Dept. 117	Mail/Addr T038	Date S. E. Reeder	
IR&D Program? Yes <input type="checkbox"/> No <input checked="" type="checkbox"/>			M. E. Lee		
If Yes, Enter Authorization No.					
Distribution			Abstract

*	Name	Mail Addr.	This report documents the history and the activities and results of the decontamination and decommissioning of the Former Sodium Disposal Facility (FSDF), also known as B/4886.		
	Marshall, R. A.	T038			
	Lafflam, S. R.	T487			
	Lee, M. E.	T038

This report documents the environmental remediation of the Former Sodium Disposal Facility (FSDF) and its current status. The radiological remediation work is complete, but chemical remediation and site restoration remain to be finished.

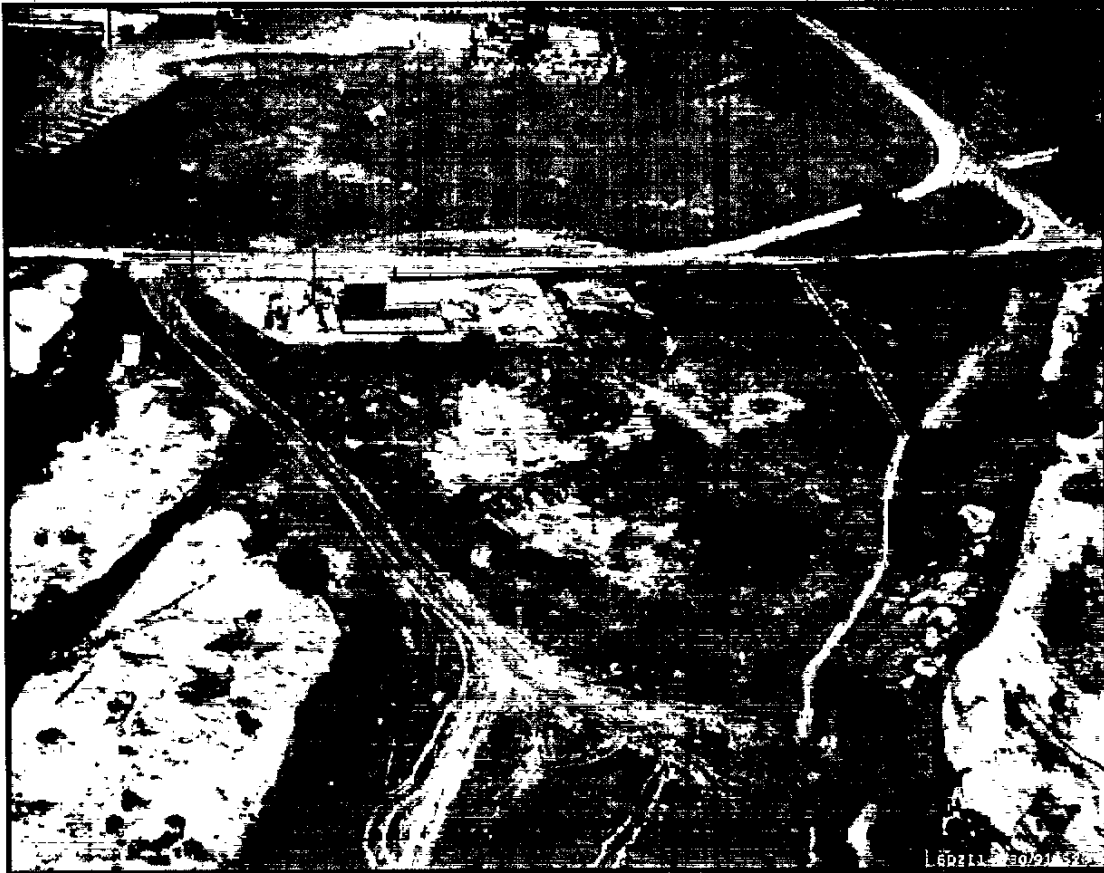
Figure 3-Former Sodium Disposal Facility (1991)

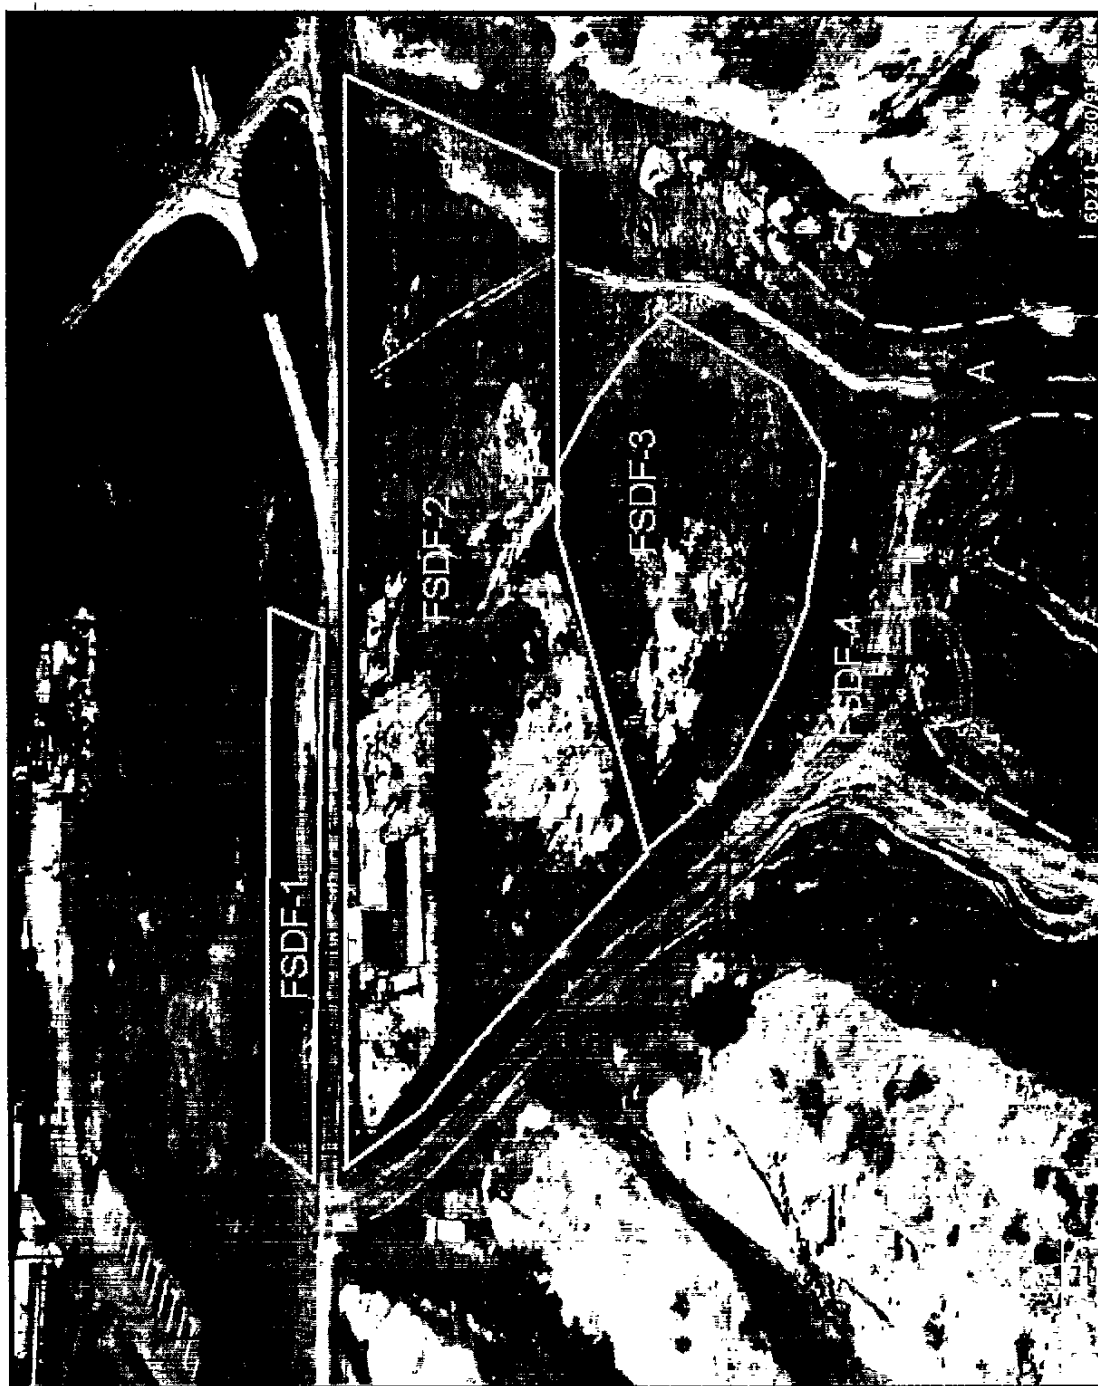
Figure 4-Designated Remediation Areas

These areas were found to be moderately contaminated, and have been partially remediated. The majority of the remaining work will be to remove the balance of soils in the upper pond, to bedrock, with some scarification of the rock to remove staining and accessible contamination. Additional soils will also be removed from the western area to achieve the cleanup objectives.

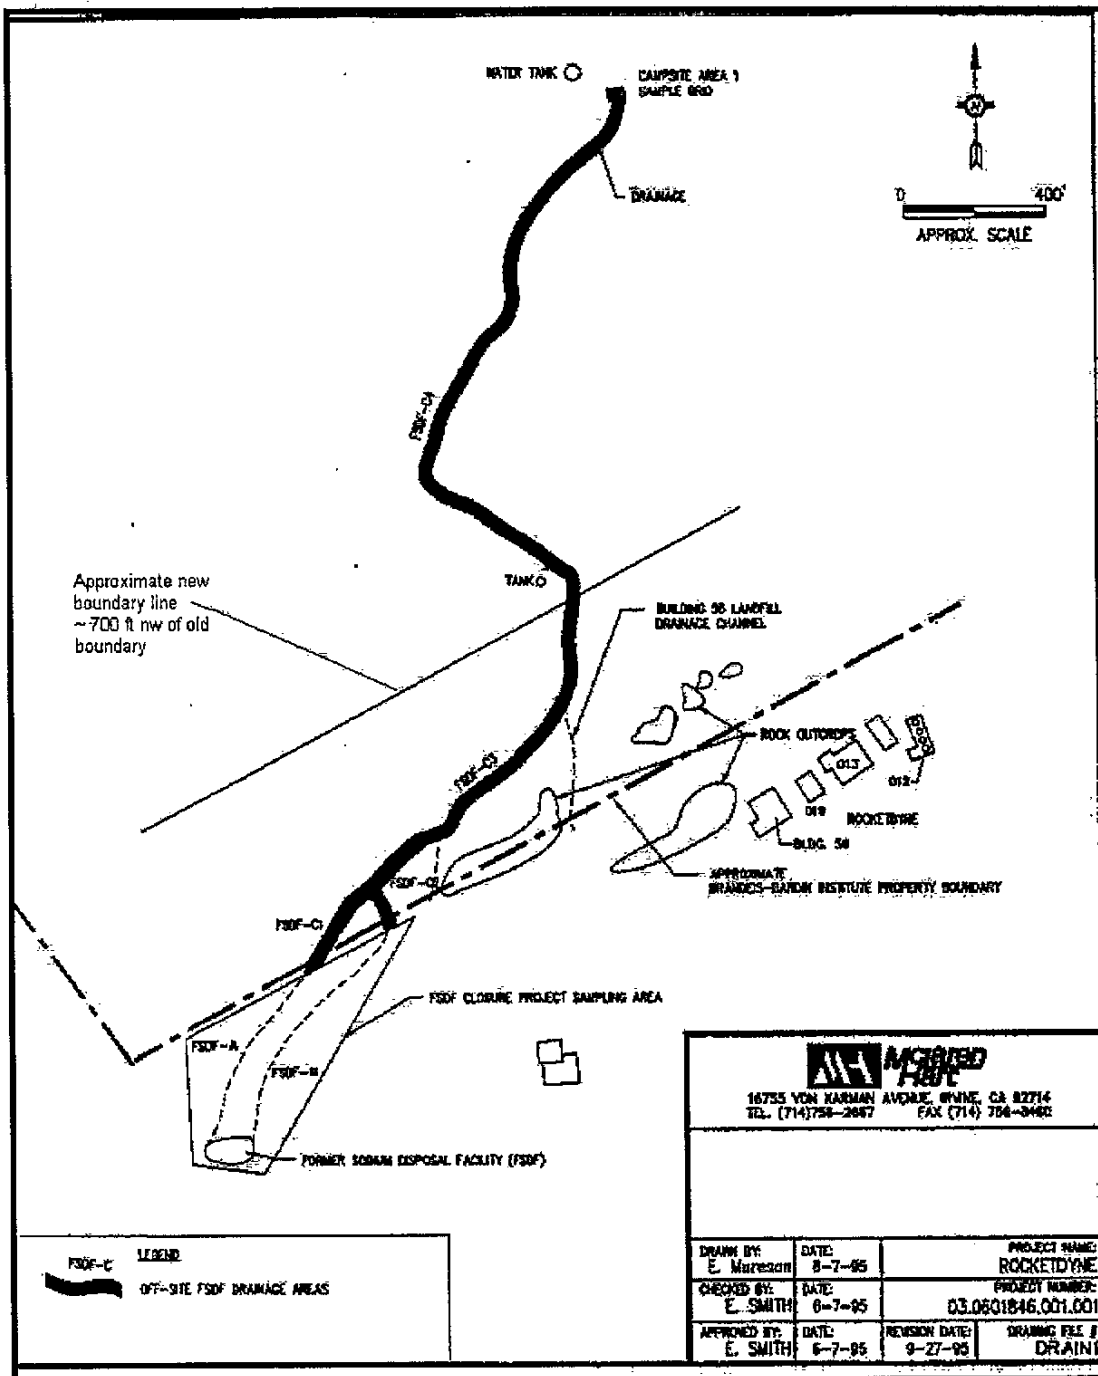
Figure 5-Off-site drainage channels

The soils and sediments in the drainage channels were found to contain residual chemical contamination, and removal of sedimentary material is planned.

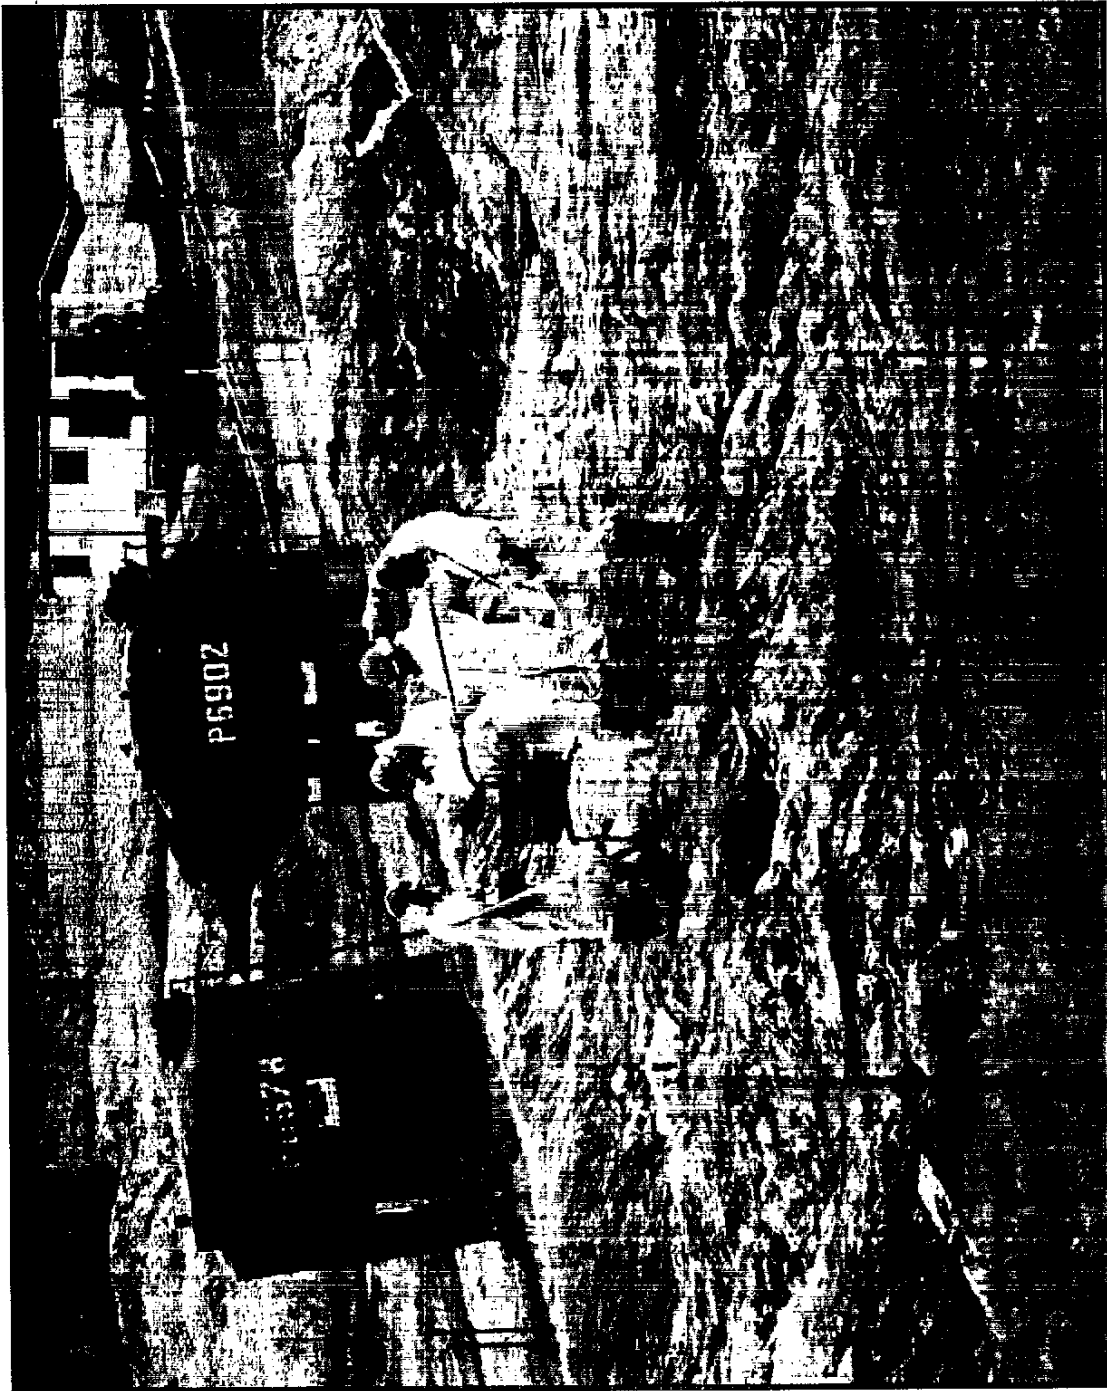
Figure 10-Excavation begins (3/92)

On March 9, 1992 - The first soil is excavated (manually, due to wet conditions) and placed in barrels, awaiting delivery of larger waste containers. Figure 10 shows this first excavation activity being conducted with shovels. Note the presence of health and safety representatives who are monitoring the soil for hazardous vapors. Visible elemental mercury was found in the soil, as can be seen in Figure 11.

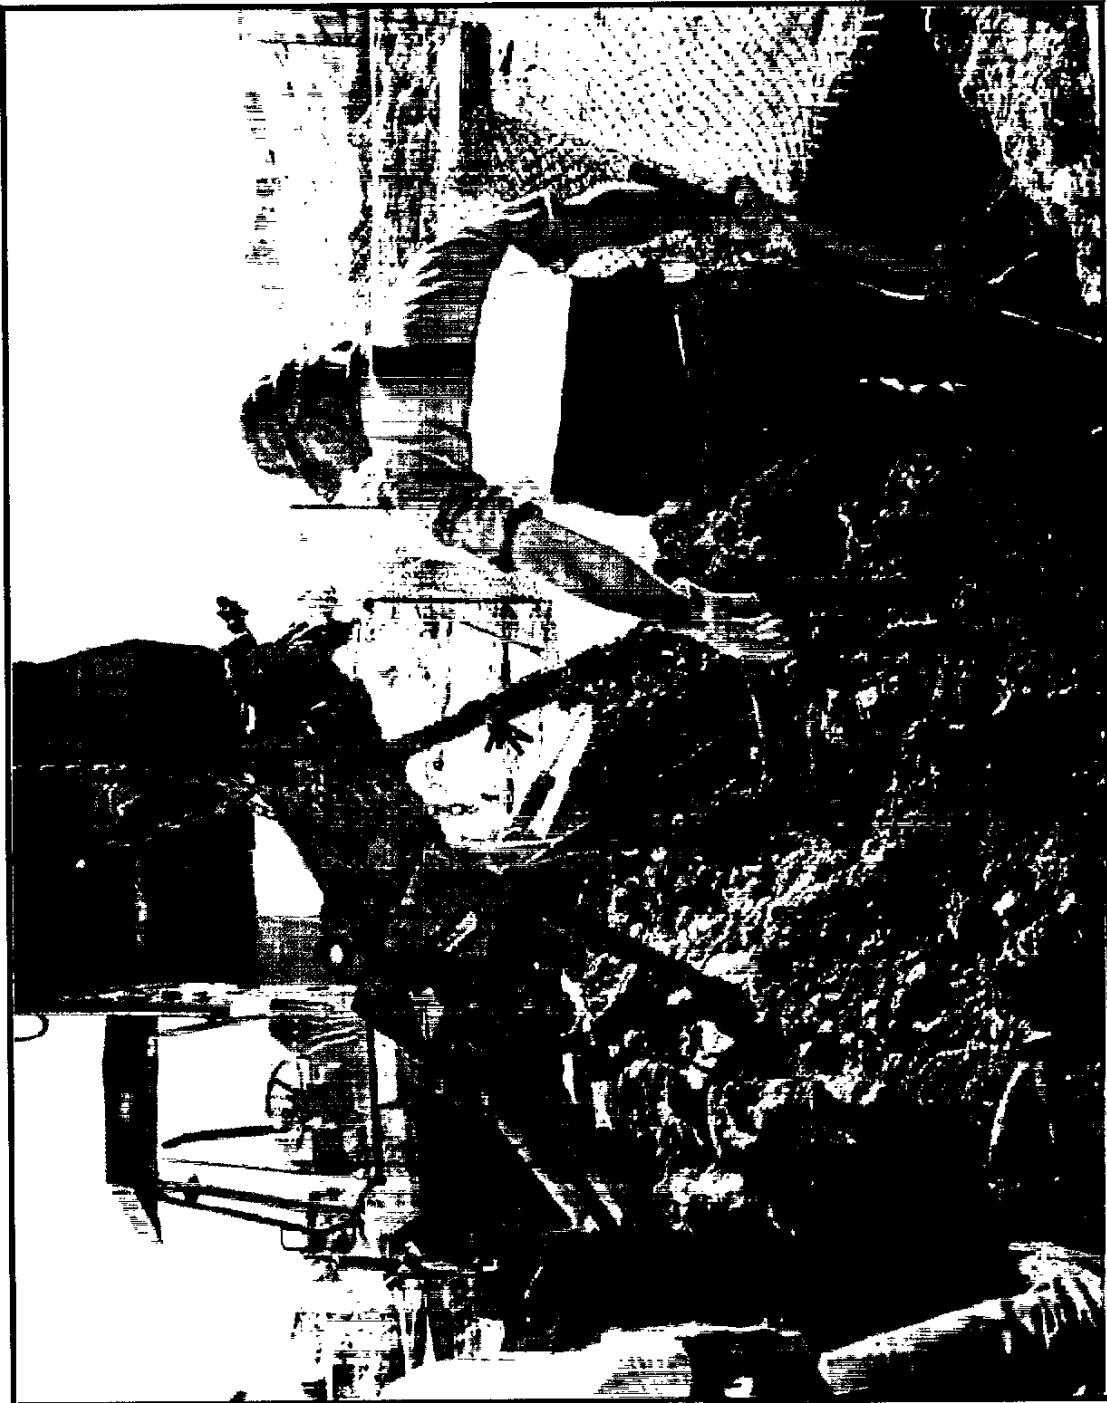
Figure 12-Excavation of subterranean objects

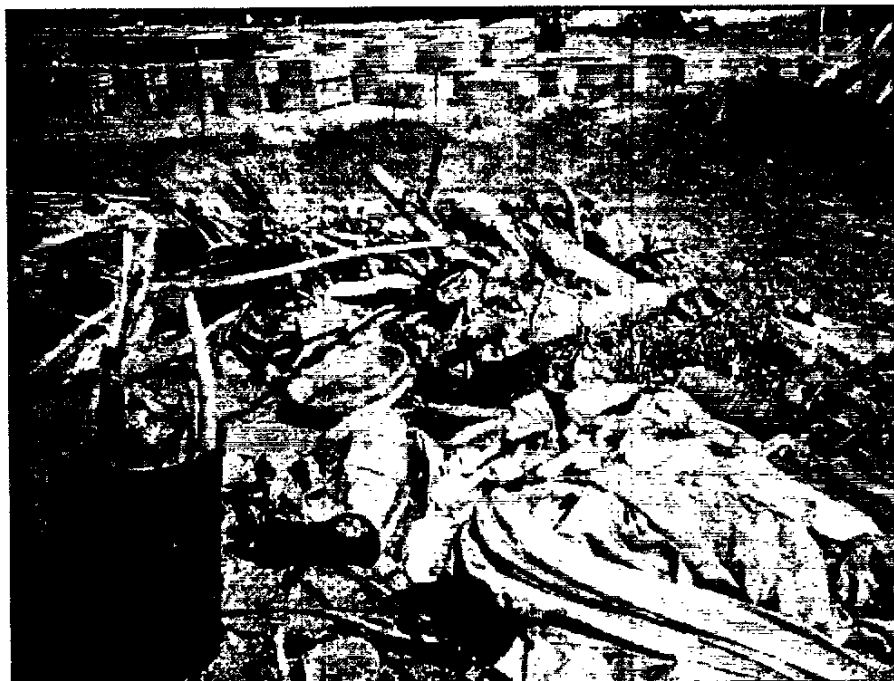
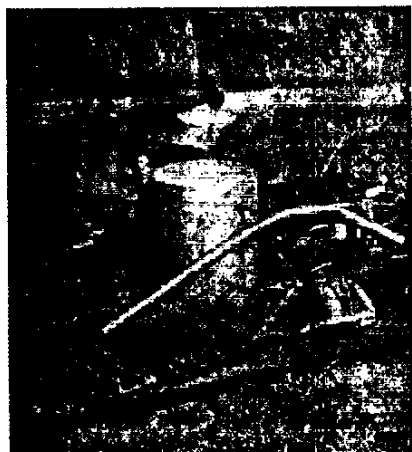
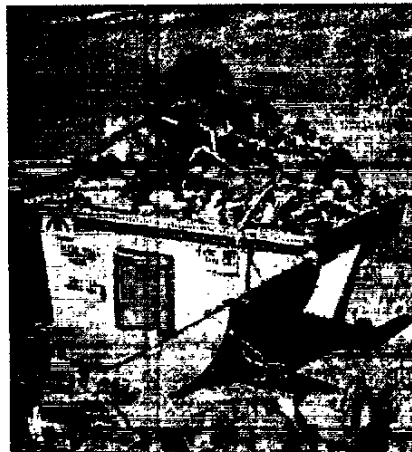
Figure 13-Exhumed debris

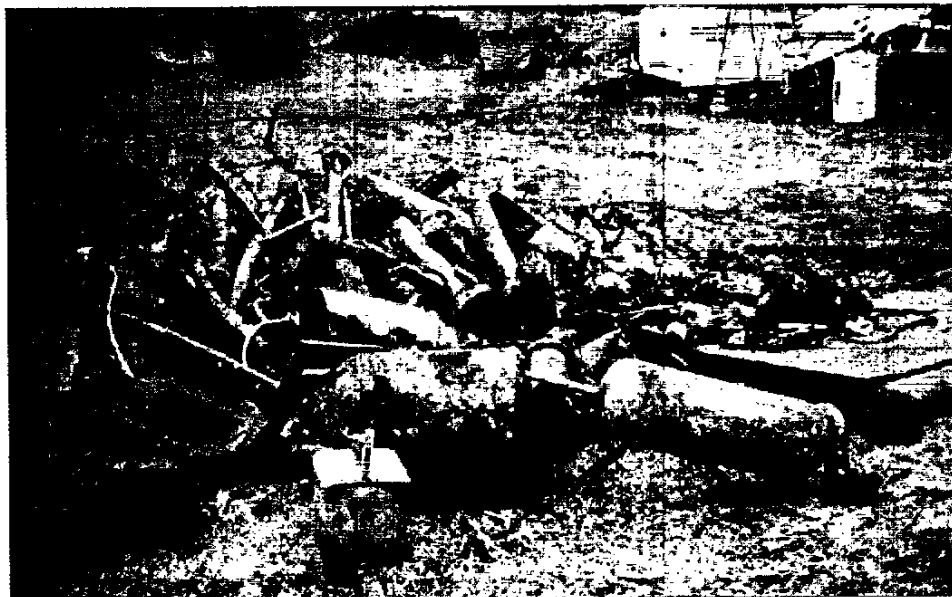
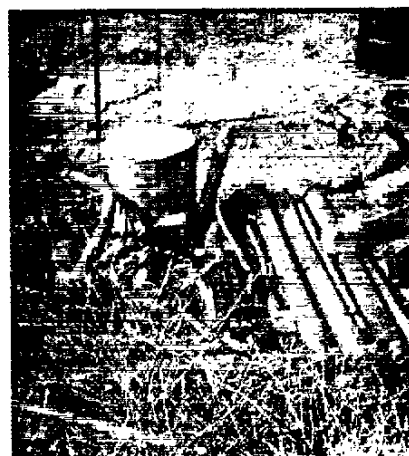
Figure 14-More exhumed debris

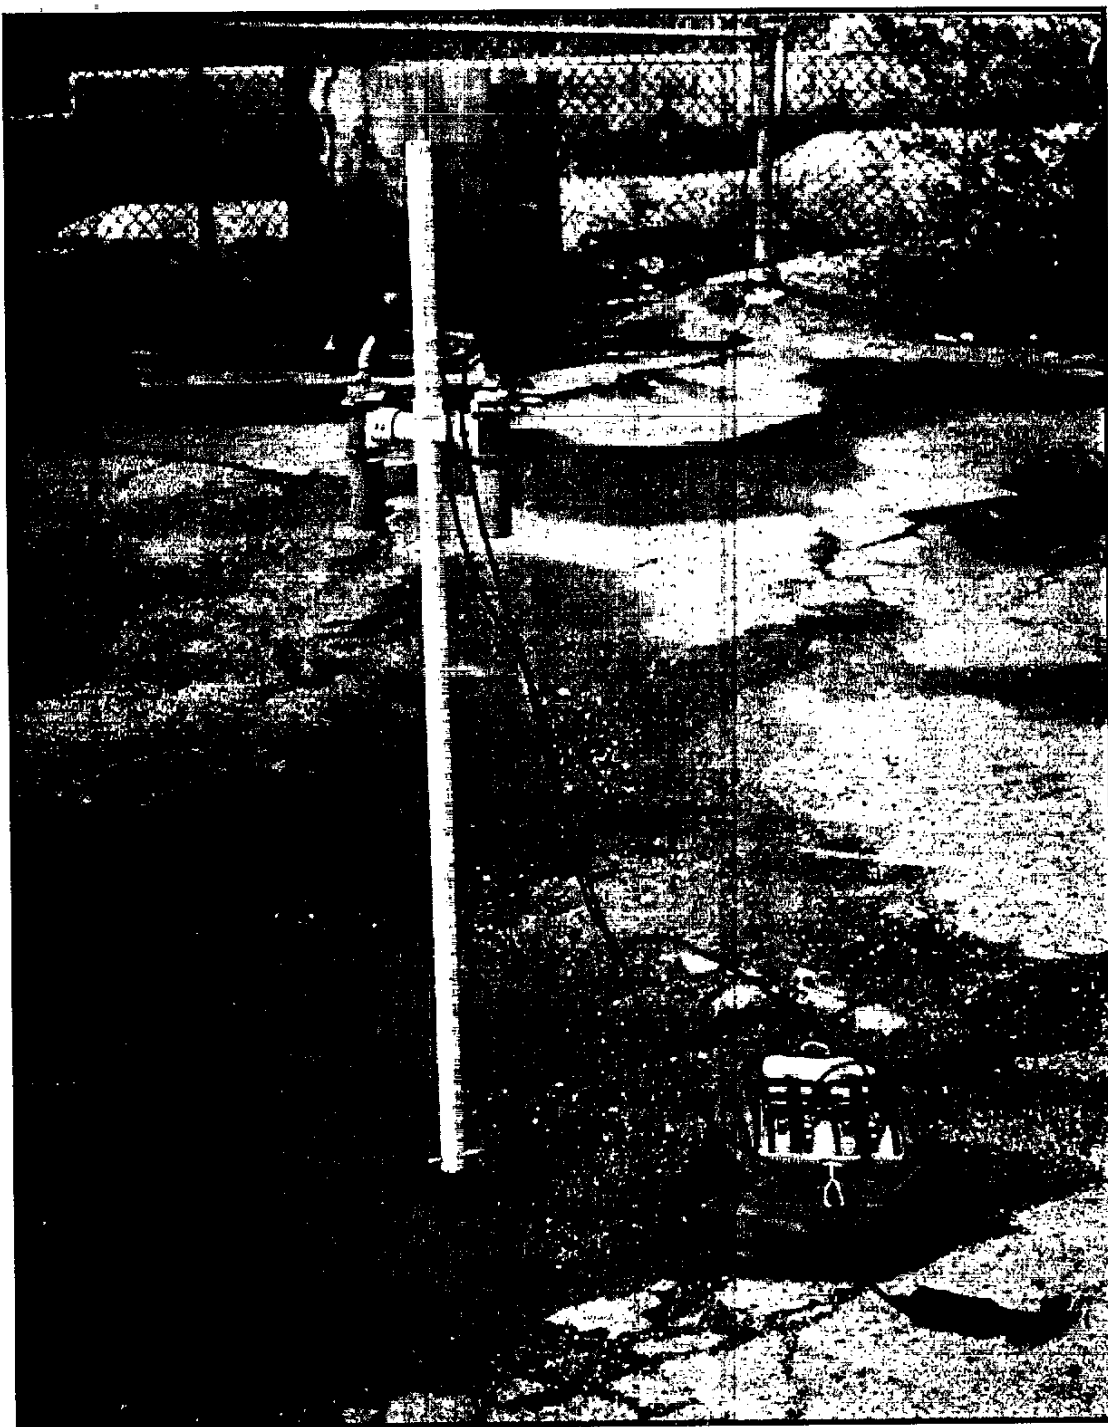
Figure 15-NaI Gamma detector instrument

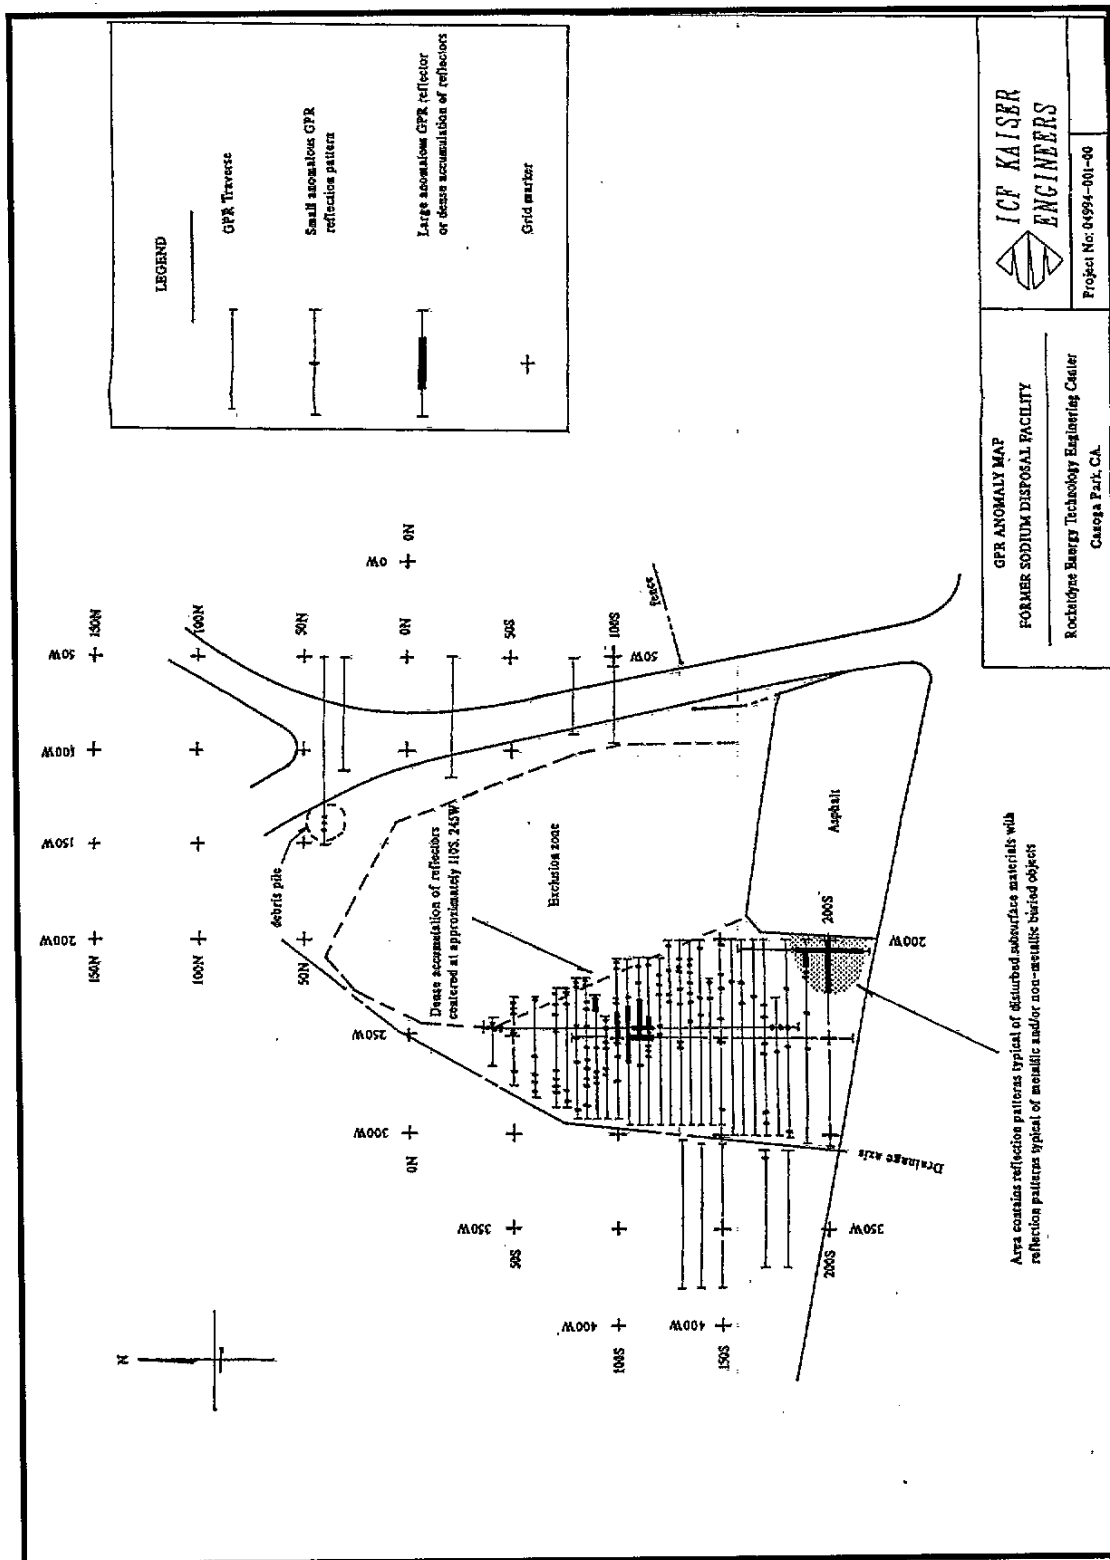
Figure 17-Geophysical map of buried objects

On April 27, 1992, the initial geophysical survey was completed and an advance map issued (see Figure 17) for buried object removal. The survey was conducted by ICF Kaiser (Reference 32) over the entire site north of the access road, except for both ponds which was going to be excavated to bedrock and the information would be of little value. This survey formed the plan for object removal and the basis for improved volumetric estimation of excavation quantities. The site was generally found to contain buried objects in the expected areas, and the soil thickness ranged from 0 to 15 feet. The results identified objects throughout the site. It is known that scrap was abandoned and, over the course of time, become covered by the effects of weather, and that scrap was buried in trenches north of the lower pond (Reference 33). Figure 18 shows technicians performing the geophysical survey.

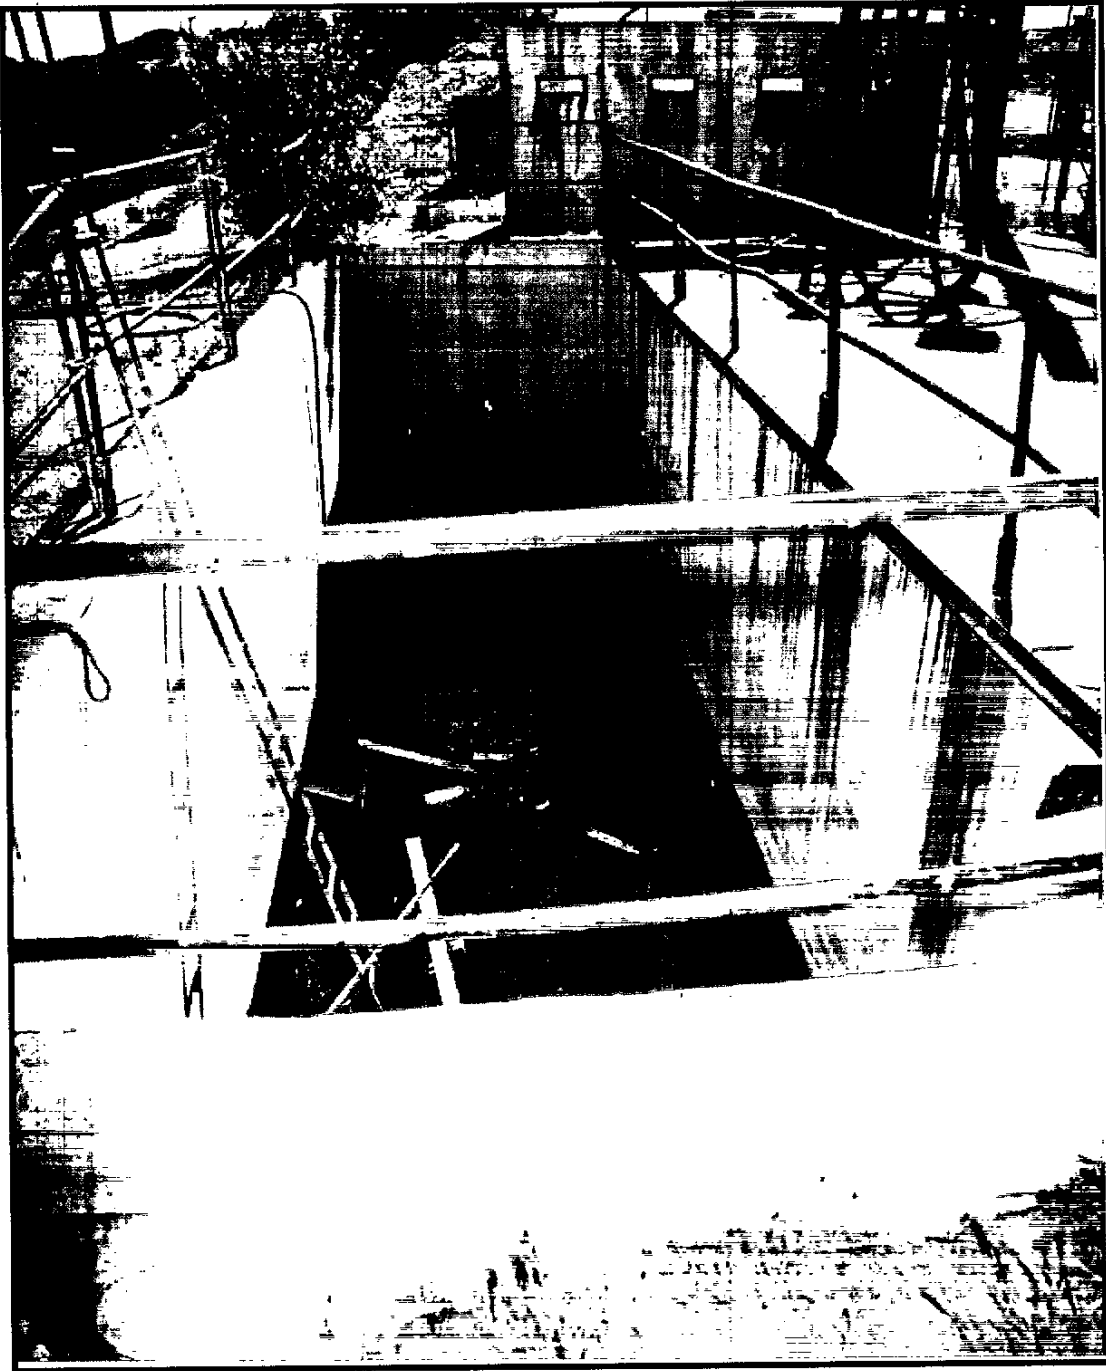
Figure 19-Submergence pit

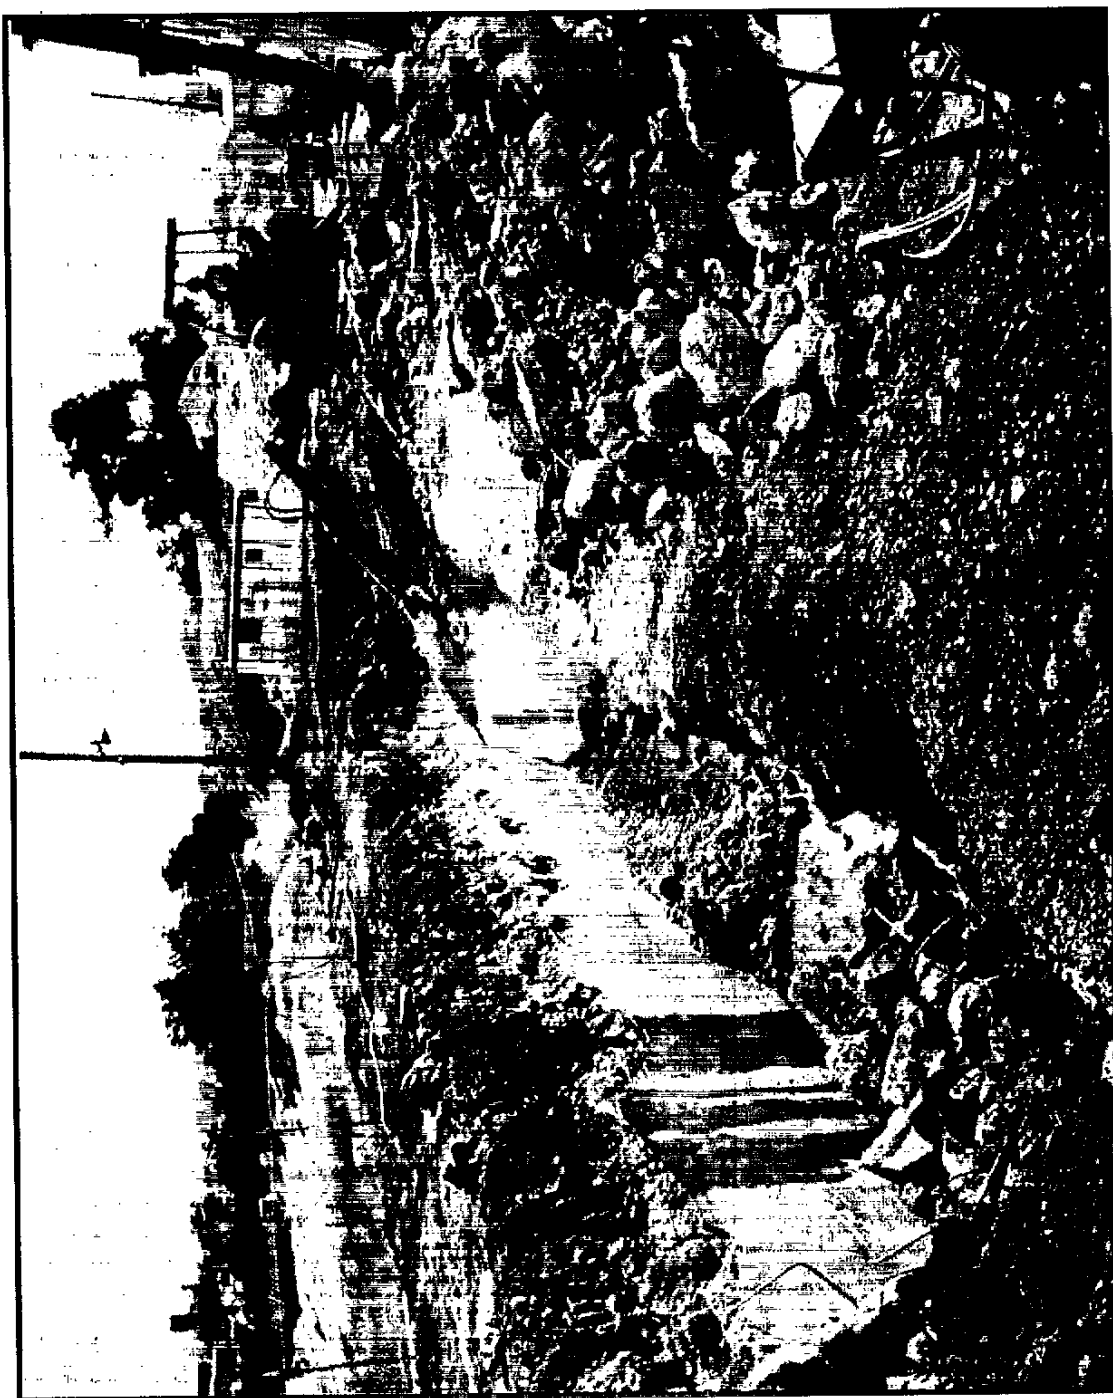
Figure 20-Demolition of pit

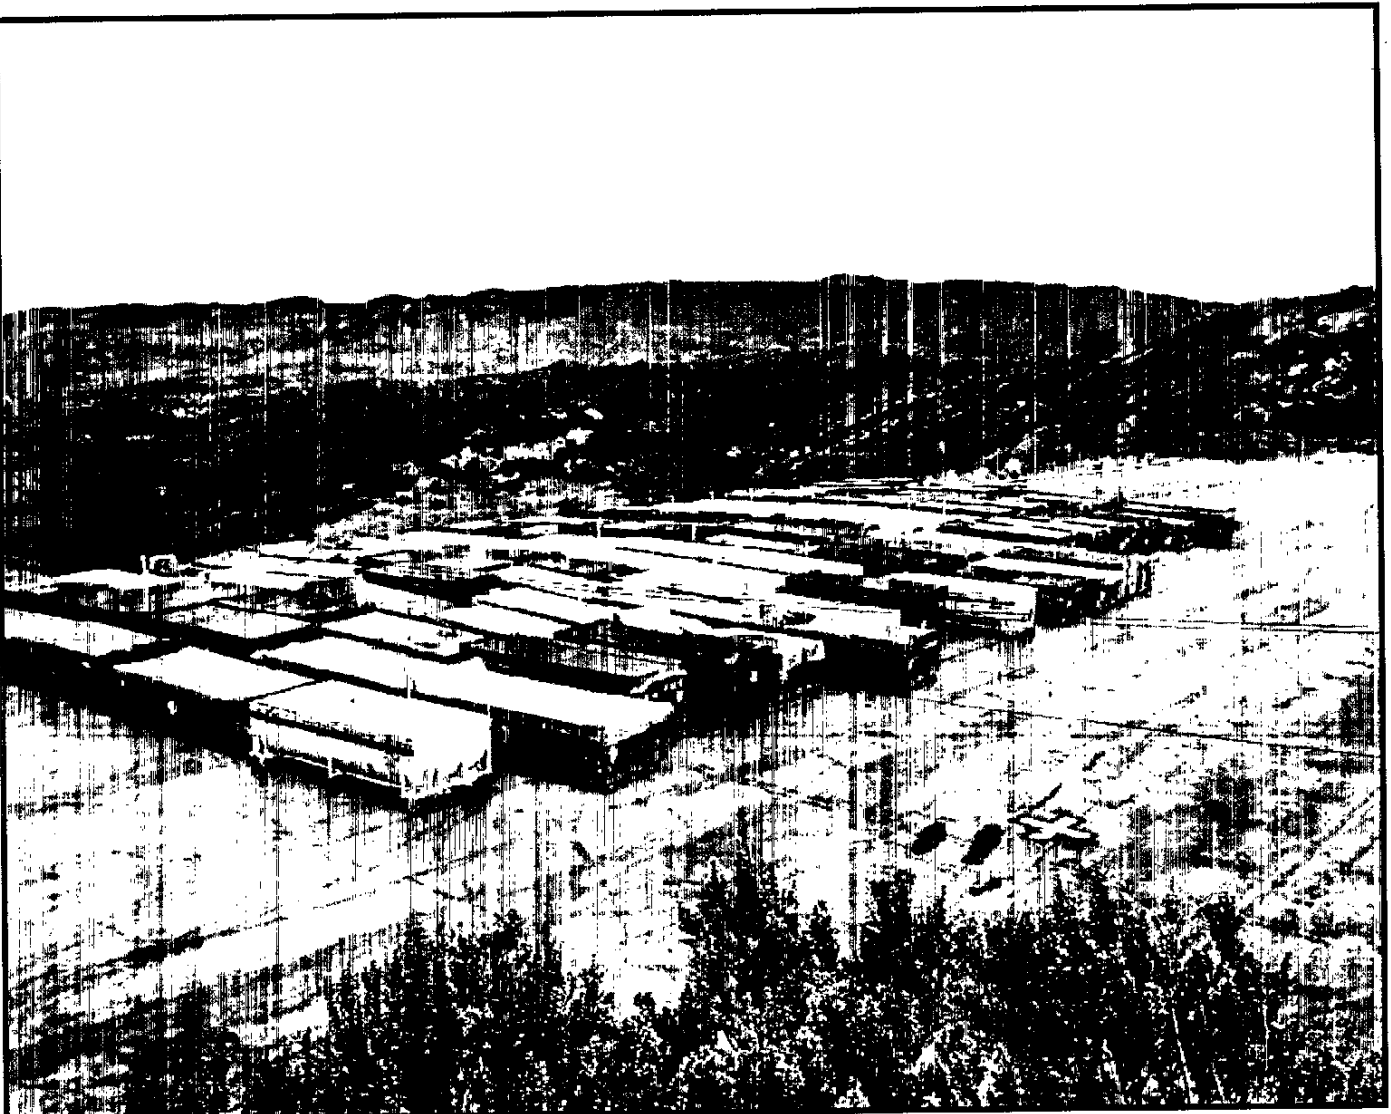
Figure 21-Filled hazardous containers (awaiting shipment)

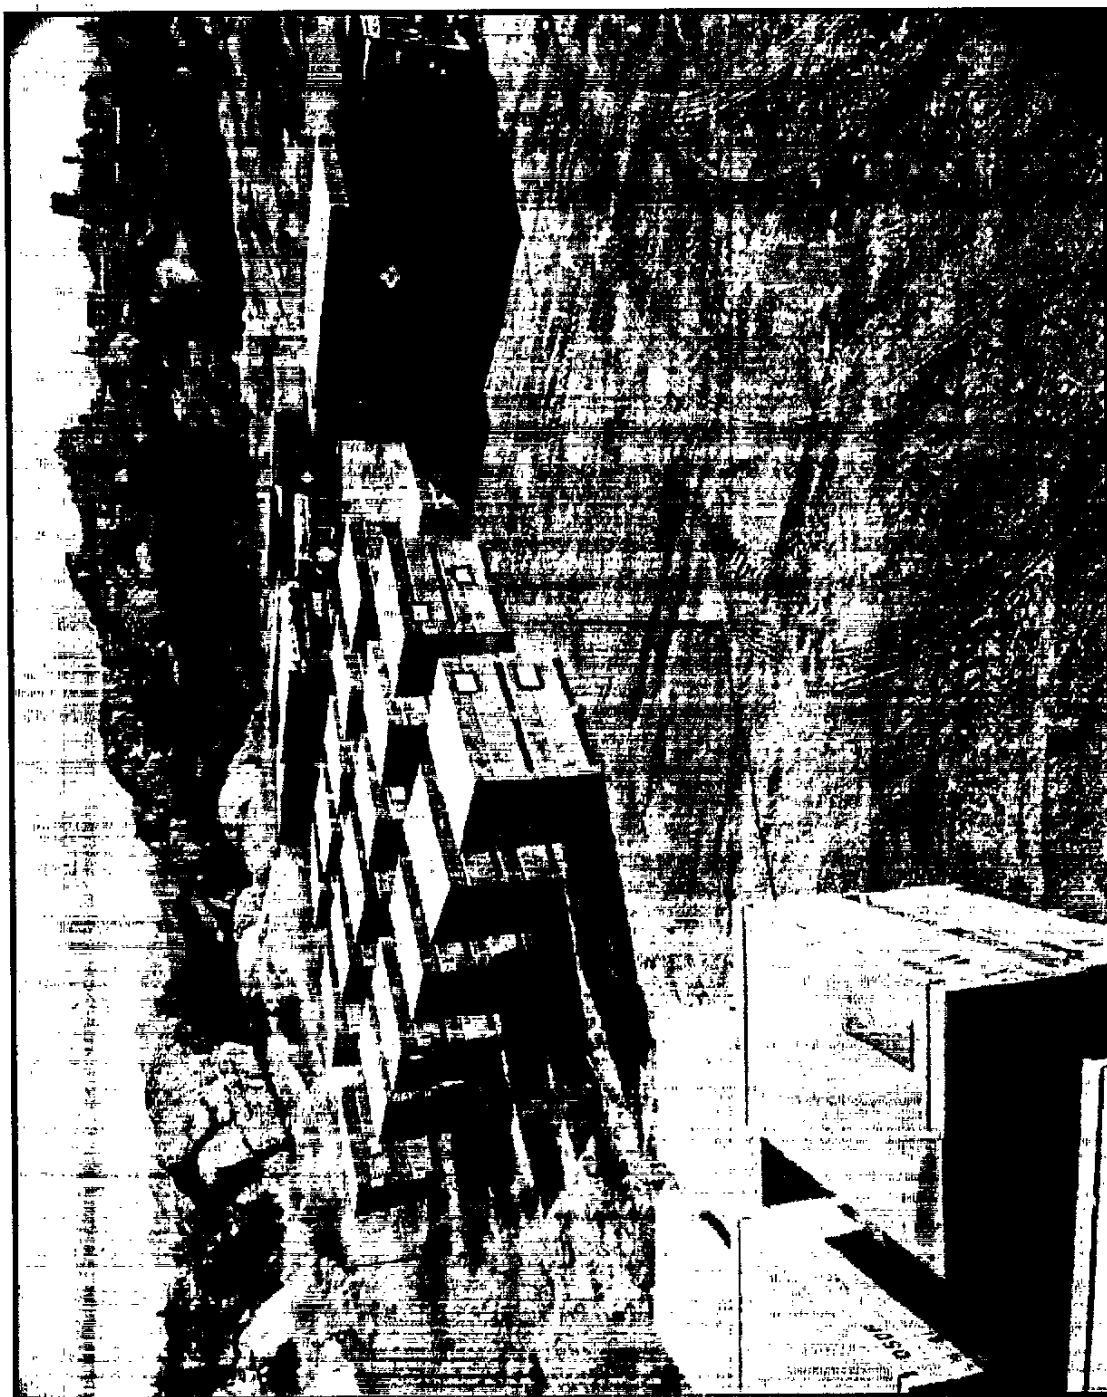
Figure 22-Radioactive waste containers (filled)

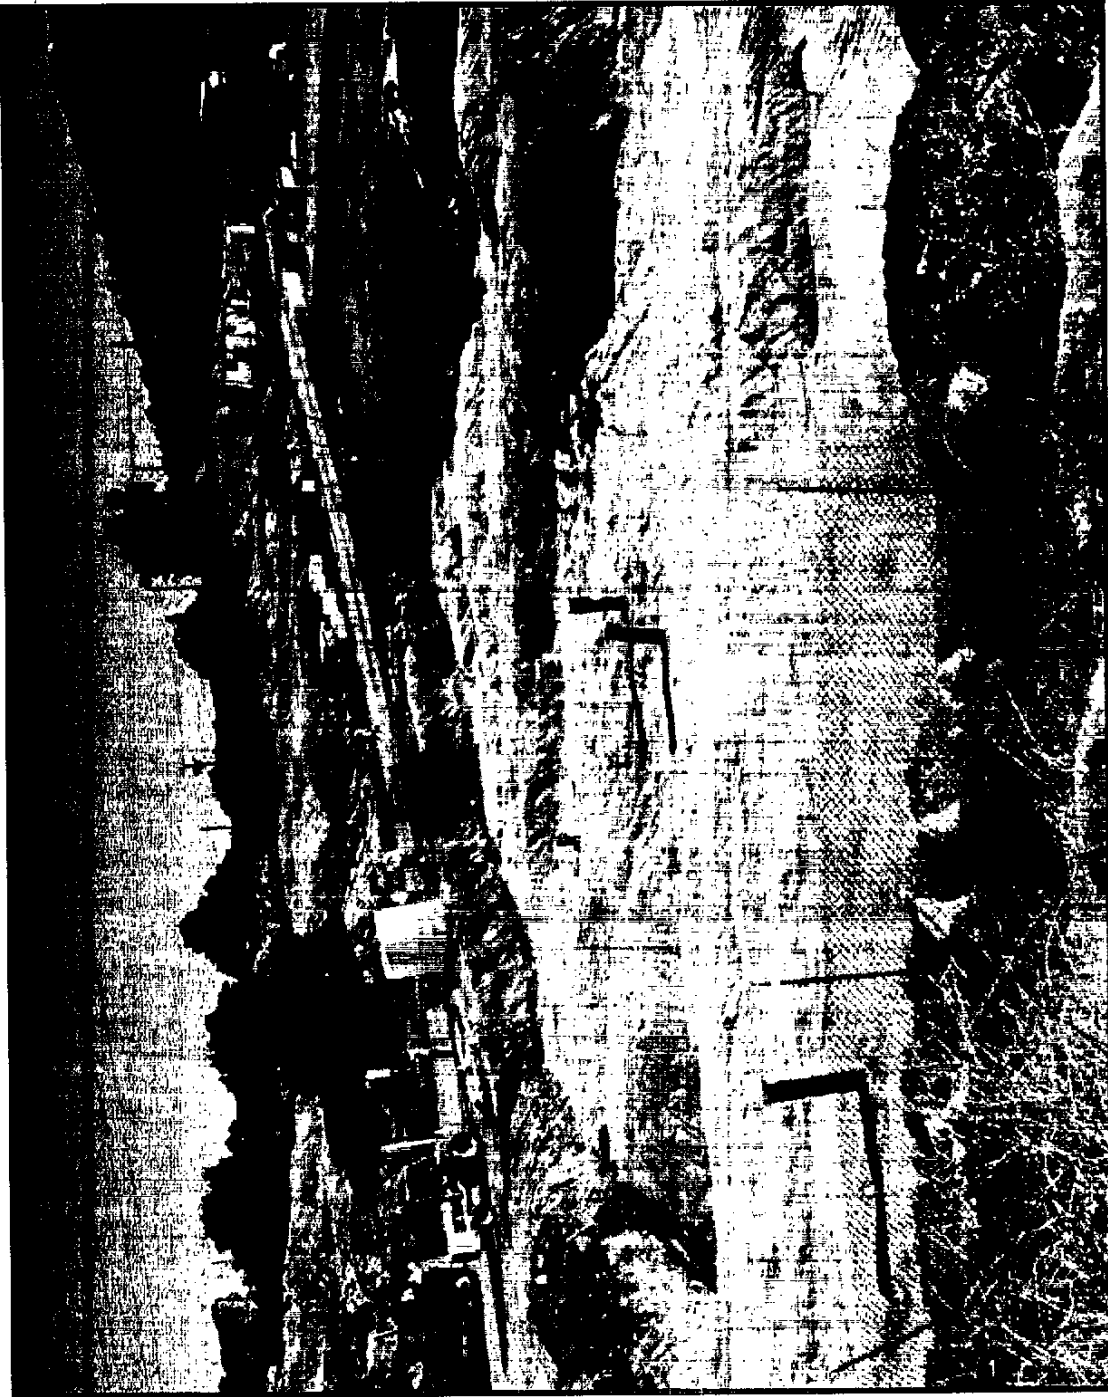
**Figure 26-Bedrock exposed in lower pond**

By December 1, 1992 the excavation of all soils down to bedrock was completed in the lower pond. Approximately 6500 cubic-yards of soil were excavated compared with original estimate of 1830 cubic-yards. Figure 26 shows the as cleaned condition of the lower pond. The photo was taken after the wells were installed however.

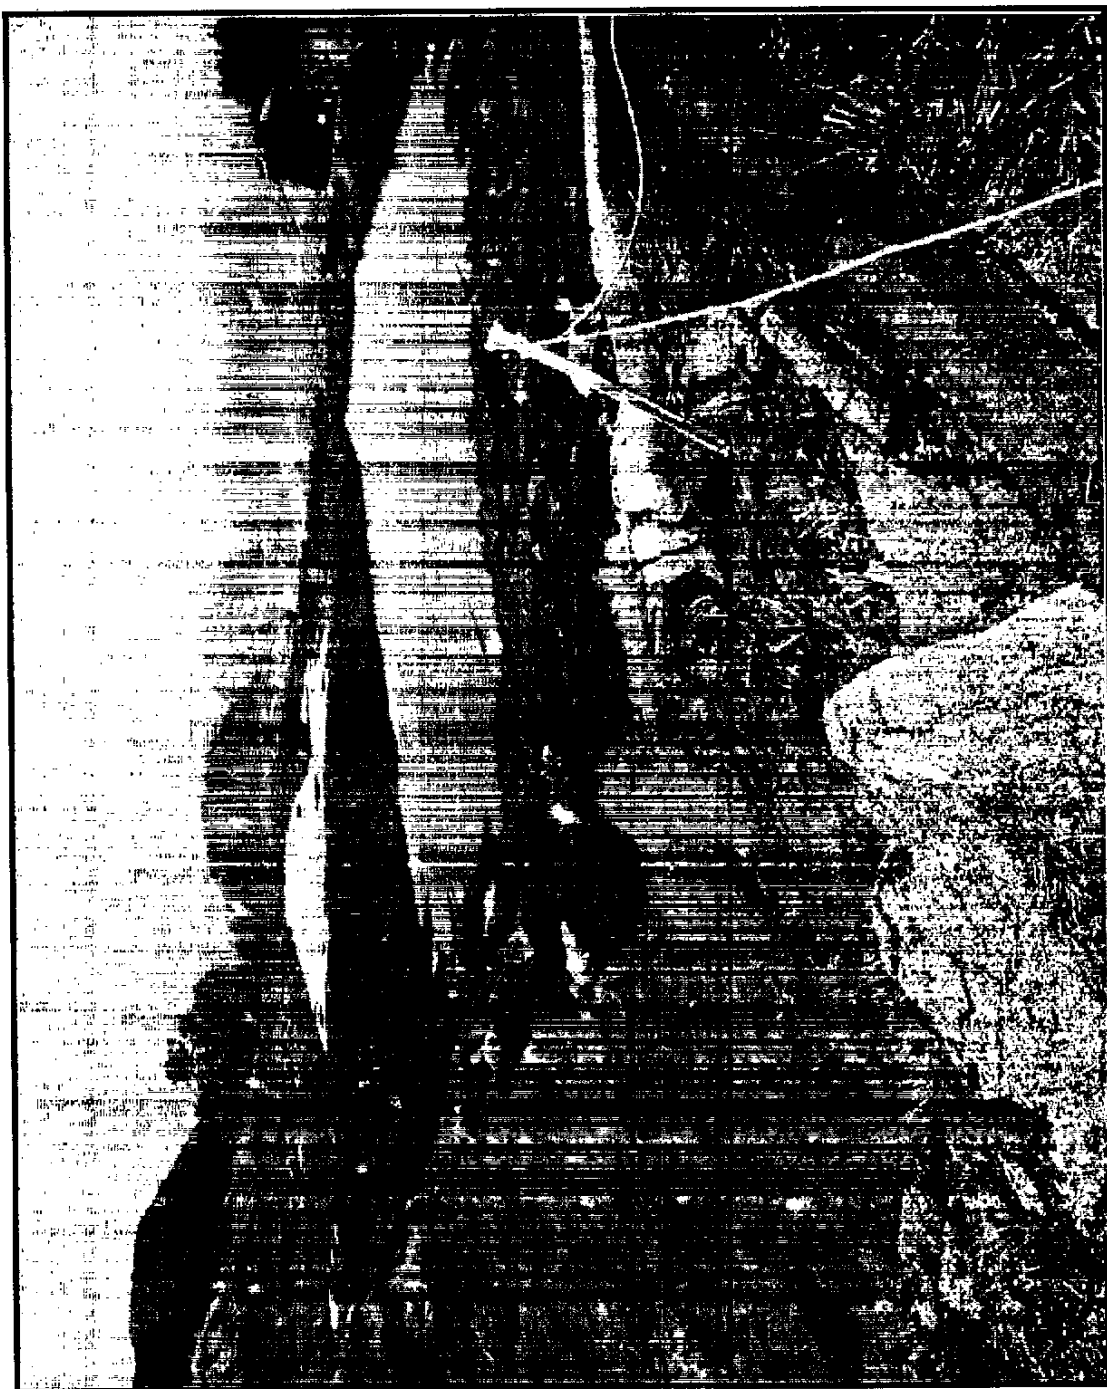
Figure 28-Tarped site during rain
